Managing Innovation using the Norman Lady and Höegh Galleon as Case Studies

Abstract

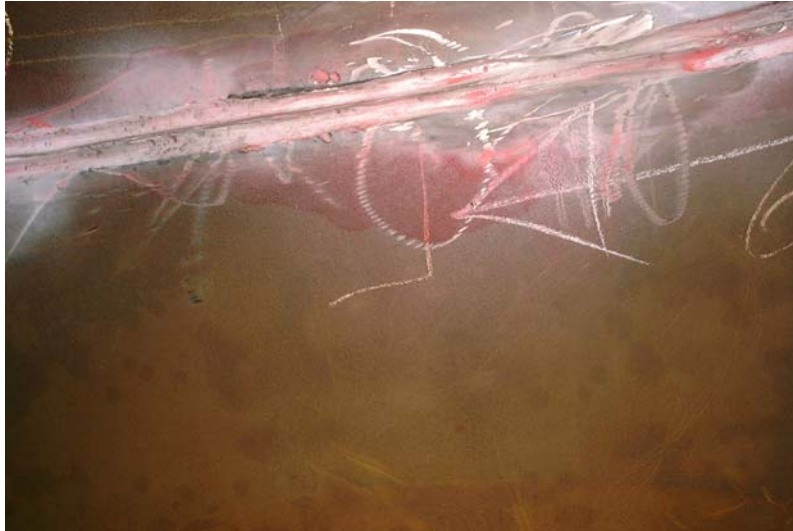
When the excavated areas were deep and wide resulting in only a thin sliver of original weld remaining between the two HAZ excavations, the two areas were combined into a single excavation. The equator areas typically had such deeper cracks and these areas were combined into a single excavation that included both original weld HAZ areas. Fig. 2 shows the combined excavation for the equator areas during welding.

Fig. 1 There would be typically a remnant of the original weld remaining between the two grooves

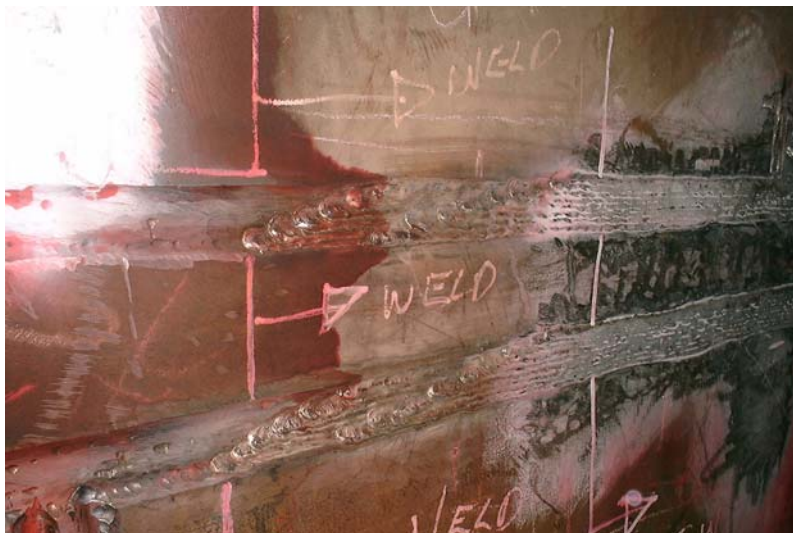
Fig. 2 shows the combined excavation for the equator areas during welding

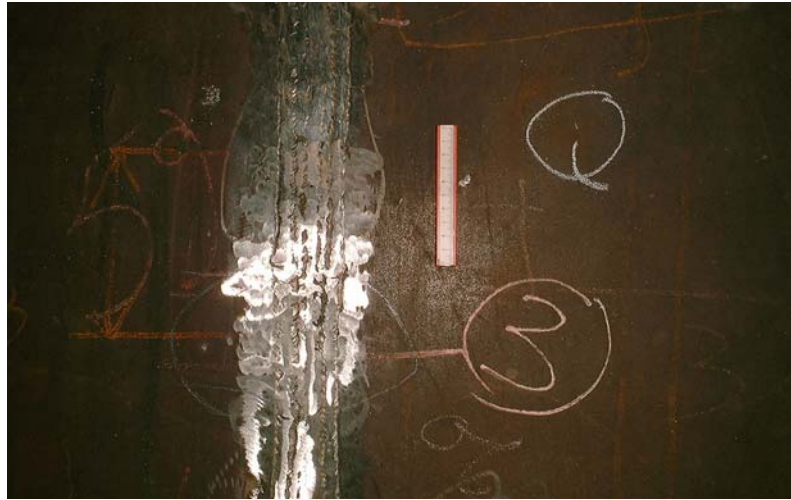
Fig. 3 show typical areas after welding and grinding

No unexpected difficulties were encountered during welding. The resulting welding appeared to be of high quality. Completed welds were ground so as to prepare them for DP examination. Figure 3 show typical areas after welding and grinding.

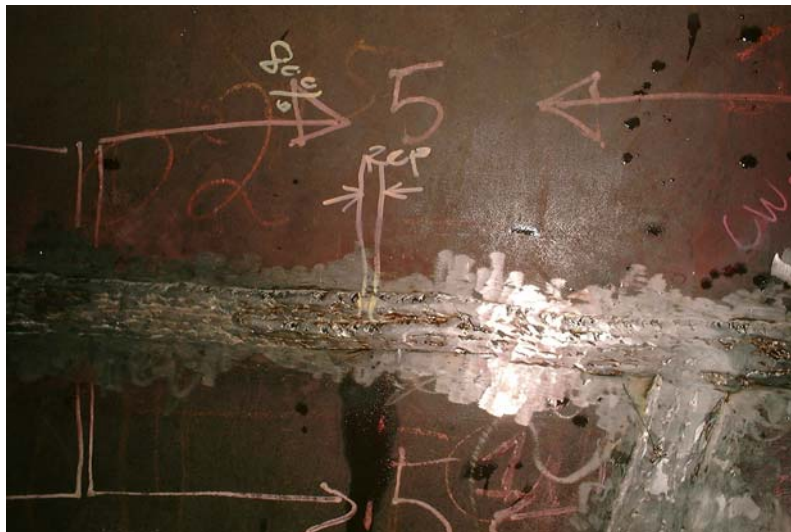
Fig. 4 shows a welded area completed & DP examined

Following welding, the completed welds were first DP examined and then Ultrasonic Testing (UT) examined. The DP examination occasionally showed small welding defects that needed to be addressed by grinding or to be rewelded. No cracking was found in any of the welds examined. Figure 4 shows a welded area that has been DP examined.

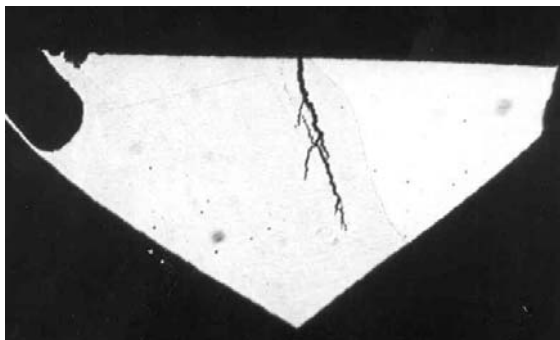
Fig. 5 Boat Sample from NORMAN LADY

Two specimens from the weldments (boat samples) were brought back to DNV's metallurgical laboratory for closer examination. This showed that cracks were present in tank no. 3, and that the cracks were caused by stress corrosion cracking. No evidence of fatigue cracking could be seen. Due to the result of this investigation DNV was requested to carry out non-destructive testing of the remaining tank nos. 1, 2, 4 and 5. This testing, which also included testing of the outside of the cargo tanks, was carried out in December 1998. The main results can be summarised as follows:

- *Wide spread cracking were found on the inside of all inspected / tested tanks.*
- *The crack depths in Norman Lady were not as deep as in Asake Maru, generally in the order of 0.5 to 3.5 mm, in four locations down to 4 mm, while a crack of 4.5 mm was found in one location.*
- *No cracks were found in the very limited areas (4 m in each of the tanks 1, 2, 4 & 5) inspected from the outside.*
- *A high hardness of the welds, up to 418 Vickers was measured across the HAZ.*
- *From the investigation of the two boat samples it was concluded that Hydrogen Induced Stress Corrosion Cracking (HISCC) caused the cracks.*
- *The testing included thickness measurements of shell plates in the inspected areas. The results indicated that the excess thickness was in the order of 0.5 -1.5 mm.*

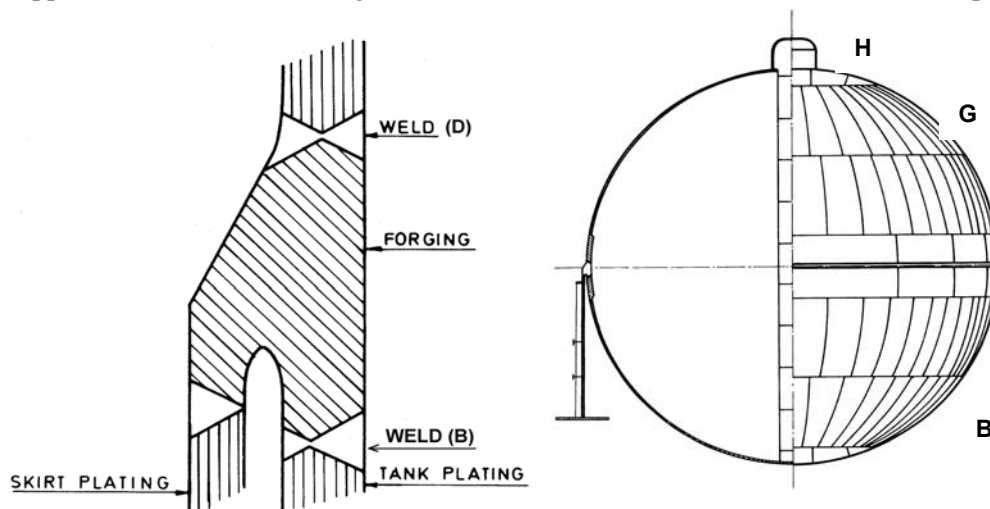
Fig. 6 Tank Configuration

Fig. 6 shows a change in thickness from 32 to 25 mm at 80° and 81° in the upper and lower hemisphere respectively. Since the inner surface is straight (smooth) the change in thickness is made on the outer surface. Shift in the mid-surface of the plates of $(32-25)/2 = 3.5$ mm leads to an extra bending moment with associated meridional bending stresses. The associated stress concentration factor on meridional (vertical) membrane stress is in the order of 1.27. This factor has been included in the fatigue & fracture mechanics analyses.
