Managing Innovation using the Norman Lady and Höegh Galleon as Case Studies

Abstract

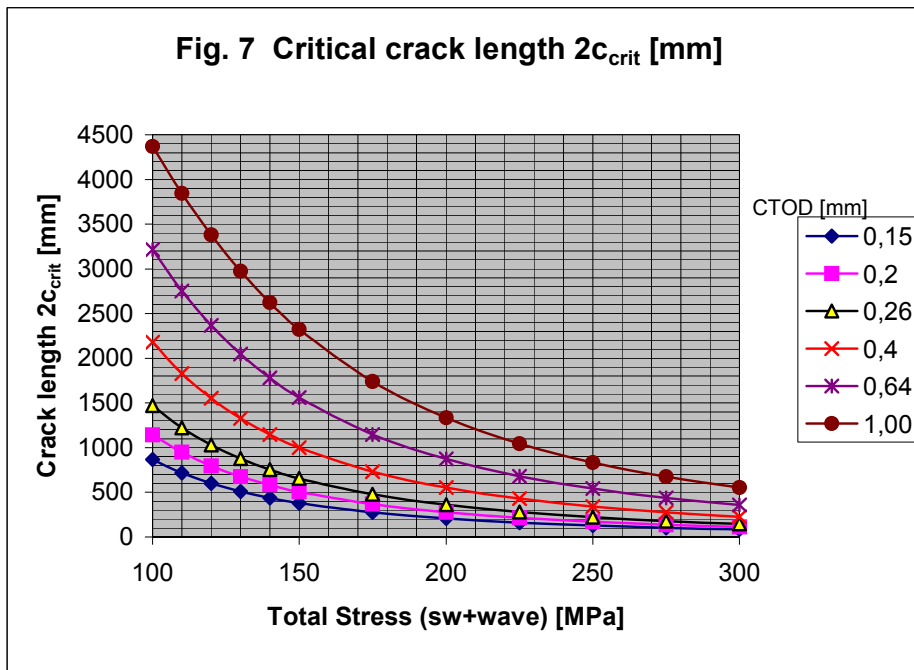
The critical crack length is defined as the maximum through-thickness crack that will instantaneously fail when subjected to the 20 year extreme load (still water + wave). Analyses for a range of Crack Tip Opening Displacement (CTOD) values and stress values have been performed by the fracture analysis software “CrackWise” developed by *The Welding Institute* (UK). Crack lengths for alternative CTOD values and stress levels are shown in Fig.7.
